**DEPARTMENT OF TRANSPORTATION****DIVISION OF ENGINEERING SERVICES**

Contract #: 04-0120F4Cty: SF/ALA Rte: 80 PM: 13.2/13.9File #: 70.28**WELDING INSPECTION REPORT****Resident Engineer:**Pursell, Gary**Address:** 333 Burma Road**City:** Oakland, CA 94607**Report No:** WIR-002886**Date Inspected:** 09-Jun-2008**Project Name:** SAS Superstructure**OSM Arrival Time:** 800**Prime Contractor:** American Bridge/Fluor Enterprises, a JV**OSM Departure Time:** 1830**Contractor:** Japan Steel Works**Location:** Muroran, Japan**CWI Name:** Chung-Fu Kuan**CWI Present:** Yes No**Inspected CWI report:** Yes No N/A**Rod Oven in Use:** Yes No N/A**Electrode to specification:** Yes No N/A**Weld Procedures Followed:** Yes No N/A**Qualified Welders:** Yes No N/A**Verified Joint Fit-up:** Yes No N/A**Approved Drawings:** Yes No N/A**Approved WPS:** Yes No N/A**Delayed / Cancelled:** Yes No N/A**Bridge No:** 34-0006**Component:** Tower, Jacking and Deviation Saddles**Summary of Items Observed:**

# WELDING INSPECTION REPORT

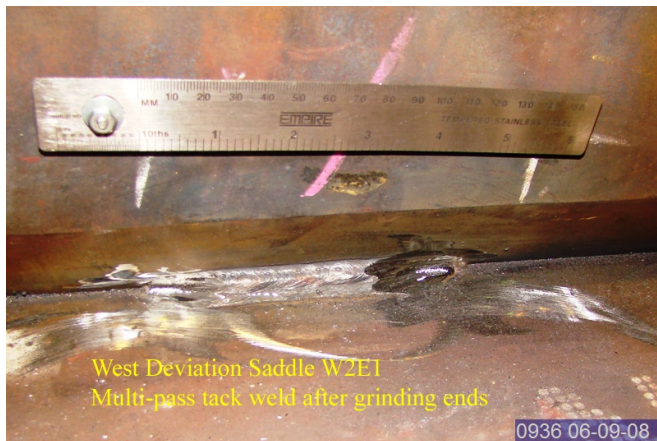
5, 2002. Mr. Sato then decided that this tack weld would be completely removed by grinding. The testing was not completed on this date and the work appears to meet the minimum requirements of the contract specifications. On this date, Japan Steel Works personnel performed grinding of West Deviation Saddle Base W2E1 multi-layer tack weld ends in preparation for further welding. The tack weld ends were ground to a smooth profile to permit a smooth transition during further welding.

The following digital photograph illustrate observations of the activities being performed.
